STAFF REPORT

# MERCURY

LOSSES AND RECOVERY

DURING A SUCTION DREDGE TEST  
IN THE SOUTH FORK OF THE  
AMERICAN RIVER

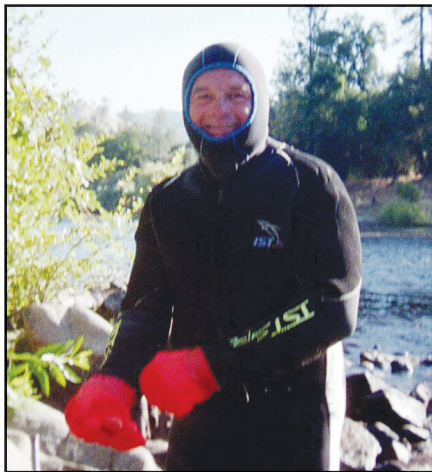
*FIGURE 2: Steve Franklin and SWRCB staff sampled the hotspot on July 8, 2003, and recovered about 125 grams of mercury in about three hours from the river using simple suction recovery tools. Mercury was visible as droplets ranging from one to ten millimeters on bedrock in the river channel. (Photo by: Rick Humphreys, DWQ)*

mercury droplets permeate the sediment at the thin upstream edge of the downstream wedge (see fig.2). Hand "fanning" stirs up fine-grained sediment, which is carried away by the river current. Elemental mercury, however, remains on bedrock, and continued fanning causes small mercury droplets to fall into bedrock depressions and fractures. When mercury droplets touch, they fuse into much **large** droplets (up to 25 millimeters). **Hand fanning the upstream sediment wedge also exposes elemental mercury in bedrock depressions and fractures** but in much smaller amounts than on the downstream side.

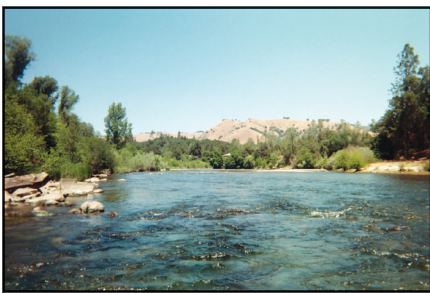
FIGURE 4: "The hotspot is located mid-channel in the South Fork of the American River, a few miles downstream from the Marshall Gold Discovery State Park at Coloma." (Photo by: Rick Humphreys, DWQ)

The hotspot is located mid-channel in the South Fork of the American River, a few miles downstream from the Marshall Gold Discovery State Park at Coloma. Surface placers and in-river gravel accounted for most gold produced from the area during the gold rush and in-river dredging recovered more gold during the 1930s and 1940s (Bulletin 193). These historic mining operations are the likely mercury source.

The hotspot is located on the downstream side of a low bedrock hump that extends across the river channel perpendicular to its flow. Because the hotspot remains underwater under all observed flow conditions, State Water Board skin divers recorded how the mercury occurred on bedrock and in river sediment visually. The bedrock hump is shaped like a low-pitched roof. River sediment forms wedge-shaped deposits on the up and downstream sides of the hump. Easily visible, small (e.g., 1mm)

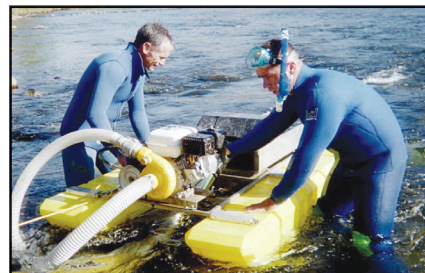
**FIGURE 8:** Jim DeMaagd and Rich Teixeira setting up the dredge. (Photo by: Rick Humphreys, DWQ)

The USFS volunteered their mineral evaluation team, based in Redding (Rich Teixeira, Jim DeMaagd, and Tera Curren), to perform the test. According to Rich Teixeira, the team's dredge is a Keene Engineering floating 4 inch dredge powered by a Honda 5.5 horsepower engine. It is similar to those used by recreational dredgers to recover gold (see fig.3). A single sluice box used carpet and riffles but no "miners" moss (i.e., woven nylon fabric placed between the riffles and carpet for enhanced gold recovery).

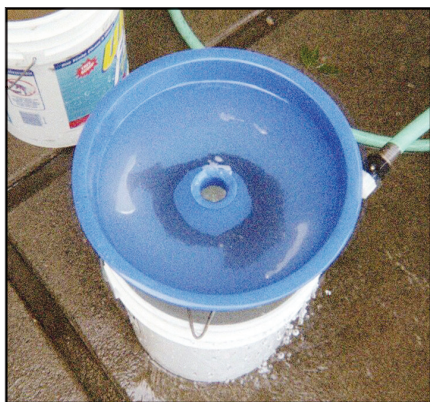
FIGURE 9. Liquid mercury (about 0.5kg) separated from sediment captured by the dredge. (Photo by: Rick Humphreys, DWQ)

The team dredged about four yards or about 5,900 kilograms (6.5 tons) of sediment from the hotspot. Team members used special care to find and dredge large liquid mercury droplets as well as mercury-laden sediment from the site. During clean up after the test, team members noted large mercury droplets captured on the sluice. From the 30-mesh passing fraction, SWRCB staff separated about 0.5kg liquid mercury (see fig. 4). The remaining 2.2kg of sediment retained a substantial amount of liquid mercury as small (e.g., 1mm) and fine droplets of floured mercury, which floated on water used to immerse the sediment. Separating residual mercury from the sediment by physical means proved impossible. The mercury content of a 1.1kg sample was determined directly heating the sample and recovering the mercury vapor (i.e., retorting). The retorted sample contained 20gm of mercury or 1.8 percent. The dredge concentrate contained 540gm of mercury (liquid mercury + retorted mercury/ 1.1kg x 2), which accounted for about 20 percent of the sample mass (540gm mercury/2.7kg sieved sample x 100). Note that the mercury concentration of captured sediment from the in river test is about ten times higher than that reported for the efficiency test. The difference likely reflects the success of the dredge team in finding and dredging up mercury droplets during the in river test.

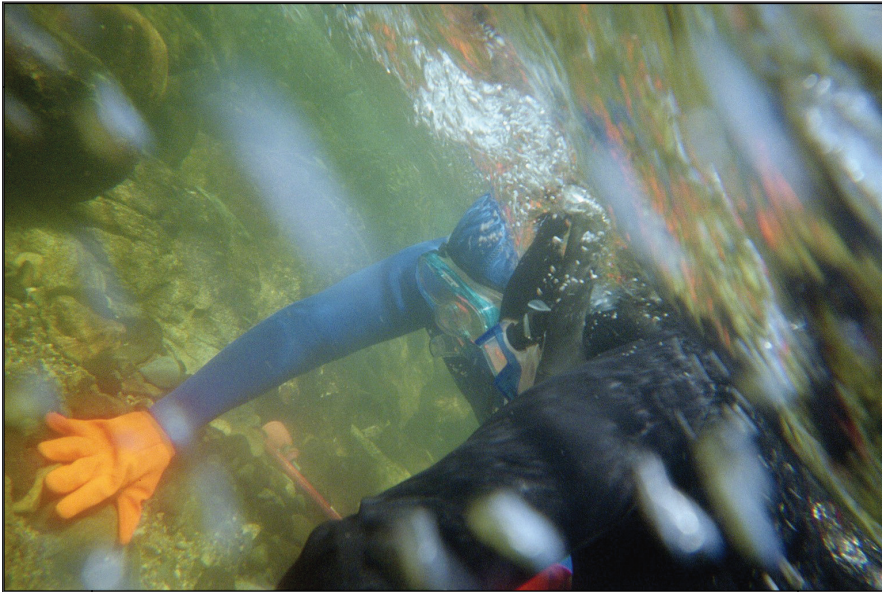
FIGURE 10: Under water diver searches for Mercury. (Photo by: Rick Humphreys, DWQ)
